AIRCRAFT ACCIDENT REPORT

MOHAWK AIRLINES, INC.

Fairchild Hiller FH-227B, N7818M

Albany, New York

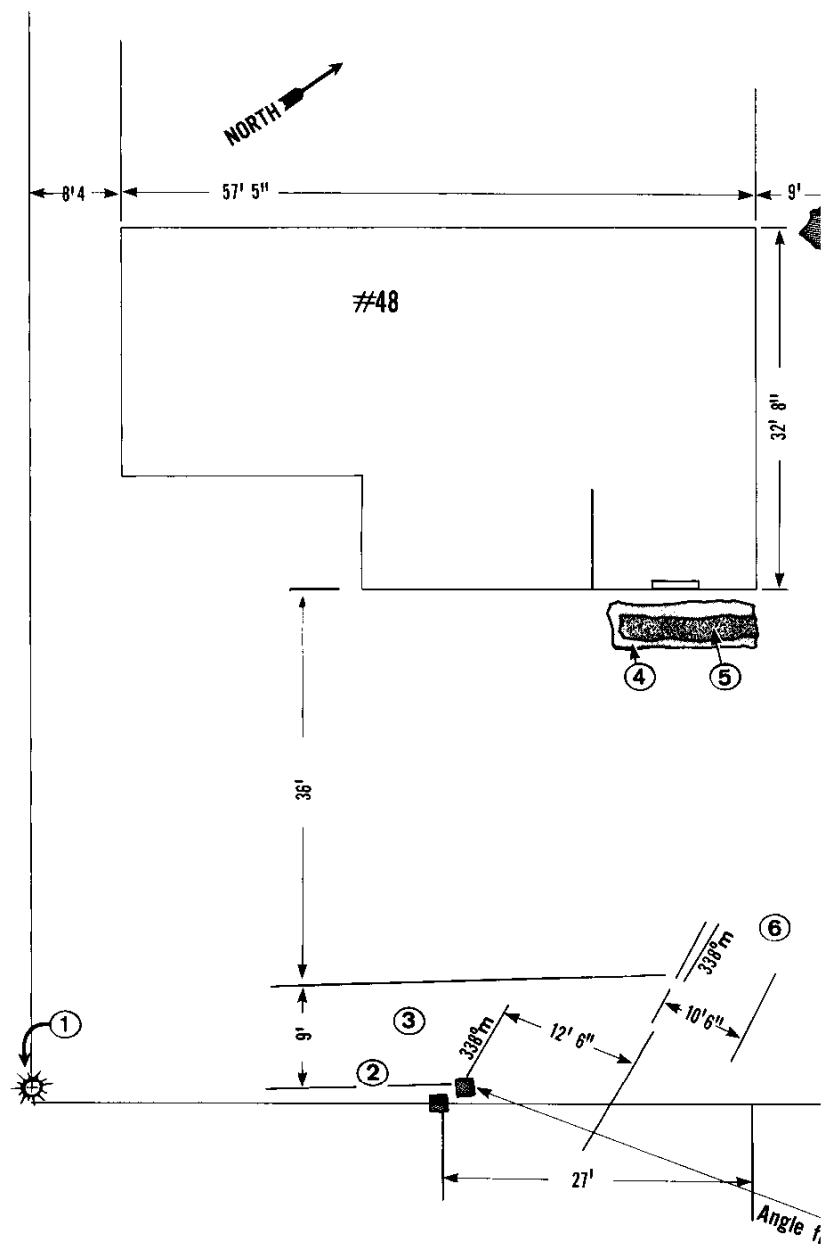
1. LIGHT POLE
2. PIECES OF LEFT WING NAVIGATION LIGHT
3. LEFT WING TIP GOUGE, INITIAL IMPACT POINT, 338° m.
4. LEFT WING TIP AND SECTION OF OUTER WING PANEL.
5. OUTBOARD SECTION OF LEFT FLAP
6. LEFT WING GOUGES, 338° m.
7. LEFT ENGINE PROPELLER SLASHES.
(1st) PROP. SLASH - 18" LONG. CENTER LINE OF SLASH TO CENTER LINE OF NACELLE MARKS 5'6"
(2nd) PROP. SLASH - 4'6" LONG. CENTER LINE OF SLASH TO CENTER LINE OF NACELLE MARKS 3'10".
8. NACELLE MARKS, 350° M
9. LEFT WING SECTION
10. SECTIONS OF LEFT WING AND LEFT FLAP.
11. AIRCRAFT NOSE STRUCTURE
12. LEFT ENGINE PROPELLER
13. RADOME
14. RIGHT ENGINE PROPELLER
15. NOSE GEAR ASSEMBLY
16. RIGHT WING TIP AND SECTION OF OUTER WING PANEL.
17. LIGHT POLE
18. LEFT LANDING GEAR
19. GOUGE

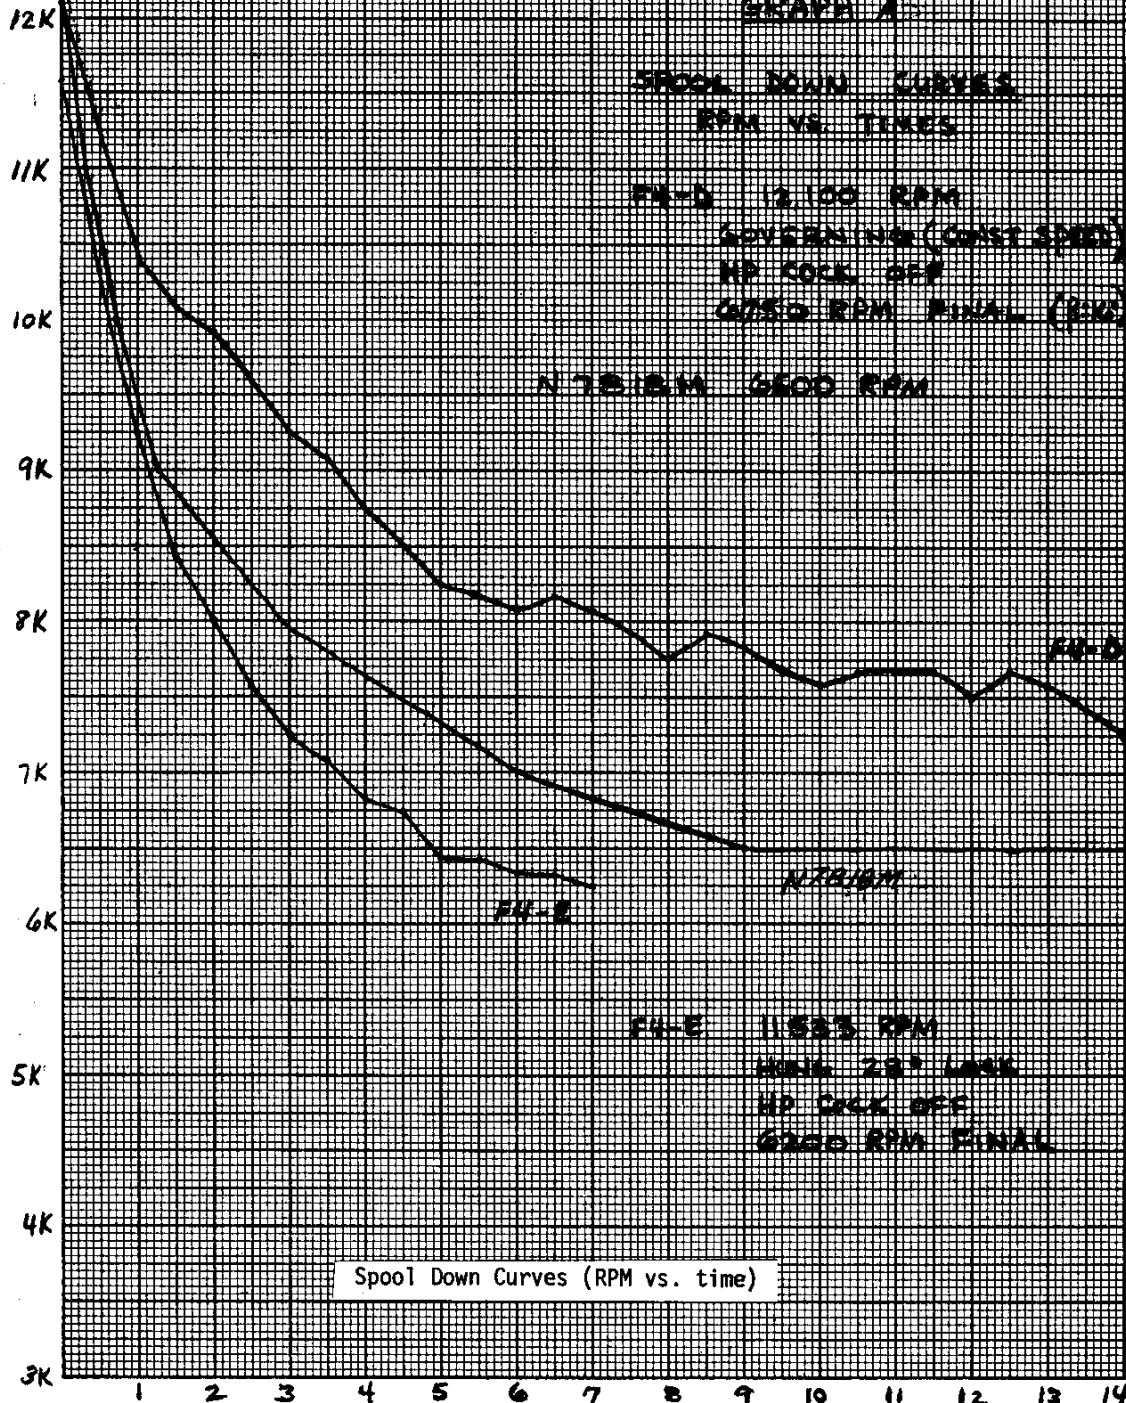
ENGINE R.P.M.

TIME~SECONDS

AIRCRAFT PERFORMANCE CAPABILITY

1. A. Left propeller powered to 12,000 RPM and constrained on 28° CPL
- B. Normal right engine operation (nominal power)
- C. Altitude = 750 feet, temperature = ISA-25° C
- D. Landing gear and flaps retracted
